Investigating Structural Cracks for Infrastructure: Case Study of Anonymous Hospital, in Zimbabwe

Abstract. The main objective of the research was to investigate the structural cracks for infrastructure at the anonymous Hospital in Zimbabwe and recommend the appropriate engineering solutions to the structural problems. Desk studies, geotechnical and materials investigations and investigations of the structural designs for the existing infrastructure was conducted. Geotechnical tests included sieve analysis, soil indicator, shear strength, direct cone penetrometer, chemical dispersive and California bearing ratio tests. Most of the cracks were structural cracks. The foundation depth was determined as 1.5 m for a bearing capacity more than 100 kPa. The causes of cracks included use of substandard bricks and construction materials, thick mortar and inadequate foundation depth. The dispersive test also proved that the soils are sodic in nature. It is recommended to use reinforced strip foundations and deep foundations when constructing infrastructure at the site. Heavy duty concrete foundation underpinning is recommended for the existing buildings.

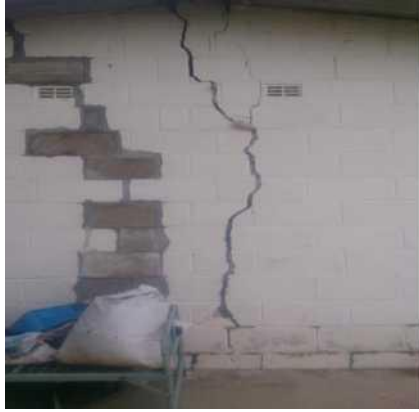
Fig. 2. A jagged vertical crack on the wall of a building

The vertical wall varied from 1 m to 5 m in length and 0.5 mm to 45 mm in width. Externally applied loads cause horizontal cracks. Settlement problems and heaving cause vertical cracks which are wider at the top and bottom. Table 1 shows the results obtained during fieldwork at the anonymous Hospital. The design limits according to BS5628 [16].

The crack widths exceeded the design limits so these are structural cracks which need to be repaired urgently, from [17] these are more than 25 mm. Geotechnical and analytical approaches were employed in the collection of the data.

From [19] for cracks up to 1 mm the damage is only experienced to the wall finishes and the treatment can be done by normal decoration. Cracks with a width from 1 to 5mm can easily be filled. Cracks from 5-15 mm require some opening up and can be patched by a mason, some bricks need to be replaced. For cracks from 15-25 mm this is extensive damage and requires breaking out and replacing sections of the wall especially over doors and windows. The walls will be leaning or bulging. For cracks more than 25 mm this is structural damage that requires a major repair job involving partial or complete rebuilding. If cracking on concrete is due to drying shrinkage the crack will stabilize, if due to foundation settlement the settlement problem must be corrected [9]. For cracks less than 1 mm bonding by injection of epoxy is recommended. Routing and sealing of cracks can be used whereby the crack is enlarged along its exposed face and a joint sealer is used to fill and seal the crack [9]. The other methods recommended include near-surface reinforcing and pinning, additional reinforcement, drilling and plugging, polymer impregnation, grouting and crack arrest [9].

It is recommended to use deep foundations, reinforced strip foundations, allowing for weep holes where terrain is highly differential, foundation underpinning and stabilising the base foundation when constructing buildings at the Anonymous hospital. It is also recommended that the structures with the failures recorded in this paper be treated with caution and repaired as some of the structural failures are far beyond serviceability failures. Using the findings from this paper, such as the repair strategies, similar studies can be done on other buildings experiencing structural failures.

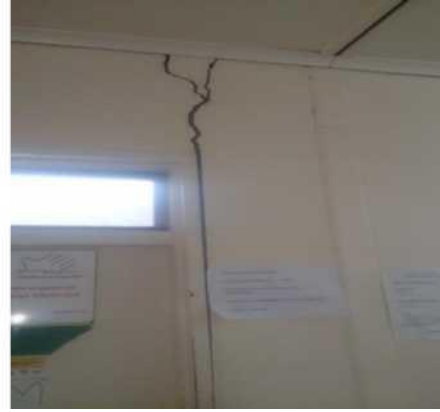
Fig. 3. Vertical crack on another building

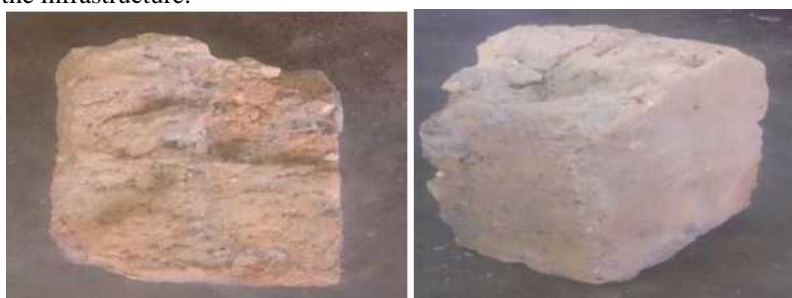
Fig. 6. Common Farm Brick collected from site shows weak bearing capacity and would crumble easily.

- The bricks utilised for the construction are of poor flexural strength and the brickwork was not bonded creating fault line vertical cracks
- The soils are sodic in nature and resulted in collapse as the sodium component dissolved with fresh water and subsequent erosion below foundations.
- The Mine company blast could not be directly sidelined though vibrations can be the reason for the increased crack width and effect of topography on foundation erosion.
- The bearing capacity of the soils in some cases was not adequate to carry the load.
