# Measures to Improve Health Performing of an Accommodation Building. A Study Case

Isabel Bentes<sup>1</sup>, Sandra Pereira<sup>1</sup>(✉), Teixeira Carla<sup>2</sup>, and Jorge Pinto<sup>1</sup>

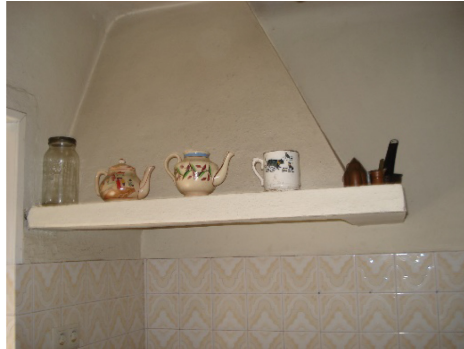
b) Traditional kitchen chimney

Among traditional Portuguese dwellings, several building technical aspects guarantee natural ventilation. For instance, conventional timber frame windows and doors usually have poor isolation, Fig. 1a. The typical kitchen chimneys allow air circulation from inner and exterior spaces, Fig. 1b. The traditional fireplaces may achieve the same feature, Fig. 2a. Meanwhile, the typical timber pavements and roofs (Fig. 2b) are poorly isolated, allowing natural ventilation through different rooms. Thus, traditional dwellings may guarantee natural ventilation, even if inefficient.

**Fig. 1.** Traditional natural ventilation solutions. Windows and kitchen chimneys.

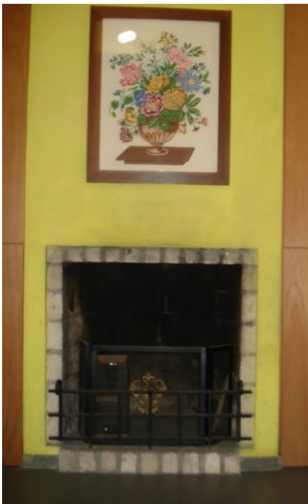
a) Fireplace chimneys

**Fig. 2.** Traditional natural ventilation solutions. Fireplace chimneys and roofs.

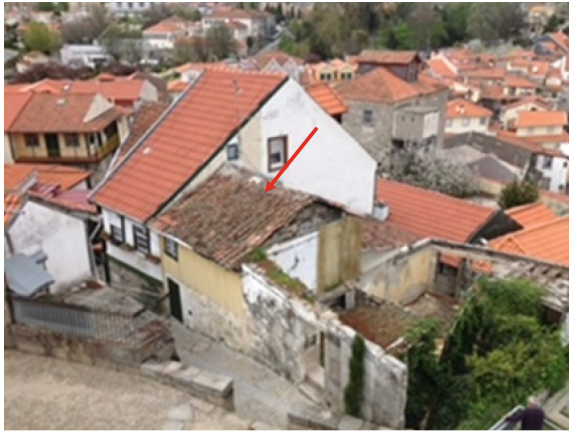
a) Before rehabilitation. Exterior

The traditional Portuguese dwelling used as a study case during this research work is shown in Fig. 3. It is a two-floor building located in the Lamego city centre, particularly in the historical part of this city near the castle.

As a typical dwelling of the North part of Portugal, it was built with exterior granite masonry and *tabique* walls. The pavements and roof were built with timber. Windows and doors were made with timber frames. The cover of the roof was made of ceramic tiles.

**Fig. 3.** The study case building.

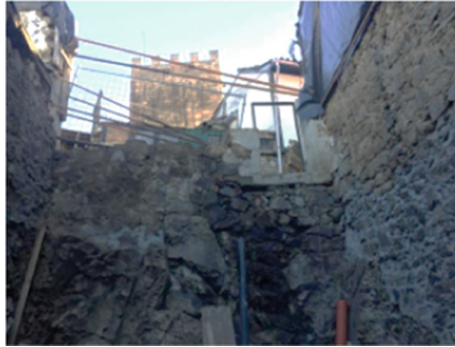
**Fig. 4.** Some highlights of the building constraints.

This specific building is lacking in terms of space. It is placed between two other traditional buildings and shares the same lateral walls, Fig. 4. Therefore, only two exterior walls are allowed to have windows, Fig. 5b. Thus, natural light and natural ventilation can be potentiated by these two walls and the roof, where it will be possible to place windows and grills.

At the same time, approximately one and a half of the building is under the level road, Fig. 4 and 5b.

On the other hand, the building presented a lousy level of conservation in which the main structural elements were almost destroyed. There was no point in rehabilitating or reinforcing most of the building. Only the external walls were maintained Fig. 4.

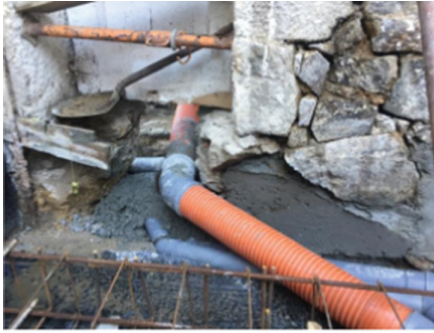
a) Ventilation pipe system

At the basement pavement, a 200 mm diameter pipe network of PVC was considered to allow the air circulation between the interior of the atrium and the North face façade at this level, Fig. 7. There is approximately a 9 m height path to take into account. Therefore, the air circulation path of the atrium is graphically presented in Fig. 5b.

**Fig. 7.** Additional building details of the atrium.

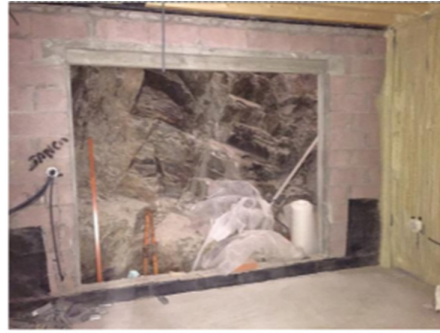
b) Back window of the abasement floor

So the proposed natural air ventilation system had to be reinforced with a forced air ventilation system (another pipe network and an electrical extractor are the components of this additional forced air ventilation system). This reinforcement was also placed on the basement pavement floor and nearby the back window of this floor, Fig. 7b.

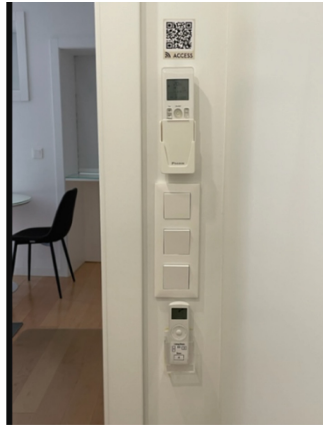
Fig. 9. Blackout curtain control devices

In addition, the blackout curtains are also remote-controlled. The respective device is shown in Fig. 9.
