Identification and Detection in Building Images of Biological Growths – Prevent a Health Issue

Abstract. Building rehabilitation is a reality, and all phases of rehabilitation work need to be efficiently sustainable and promote healthy places to live in. Current procedures for assessing construction conditions are time-consuming, laborious and expensive and pose threats to the health and safety of engineers, especially when inspecting locations that are not easy to access. In the initial step, a survey of the condition of the building is carried out, which subsequently implies the elaboration of a report on existing pathologies, intervention solutions, and associated costs. This survey involves an inspection of the site (through photographs and videos). Also, biological growth can threaten the humans inhabiting the houses. The World Health Organization states that the most important effects are increased prevalences of respiratory symptoms, allergies and asthma, as well as perturbation of the immunological system. This work aims to alert to this fact and contribute to detecting and locating biological growth (BG) defects automatically in images of the facade of buildings. To make

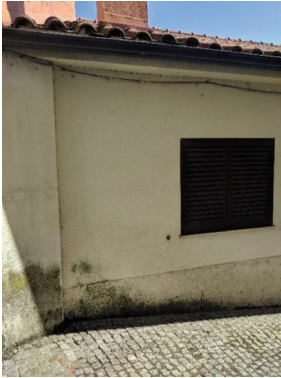
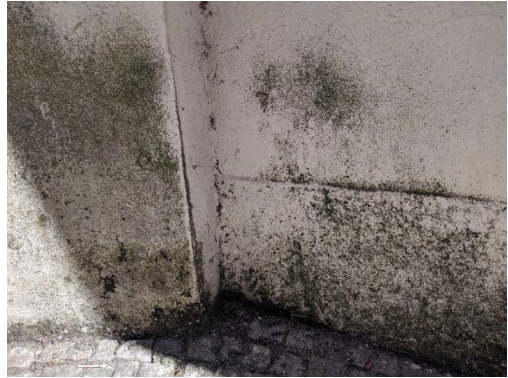
Fig. 1. Presence of BG in a building façade.

According to [21], the stains resulting from the accumulation of filamentous fungi on any substrate can be scientifically designated as mould. These microorganisms cause the appearance of dark spots with black, brown or greenish tones, which not only affect

the visual quality of the facades but also gradually deteriorate the coverings and the support itself. In Figs. 1a and b, it is possible to see an example of the presence of fungi on a facade.

a) Façade with the presence of BG

b) Detail of fungi in the façade

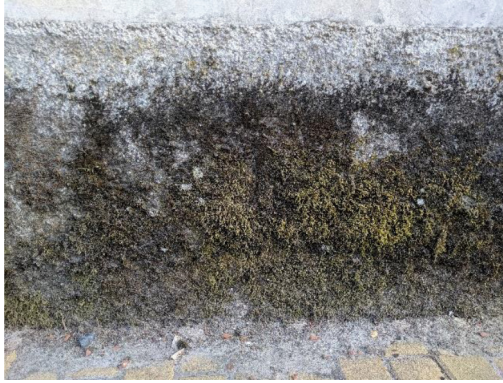
Mosses are bryophytes that preferably live in damp and shady walls, on which their reproduction depends. The humidity may be due to infiltrations or ineffective waterproofing. Figure 2 shows an example of mosses on facades.

Fig. 2. Detail of a building façade with mosses.

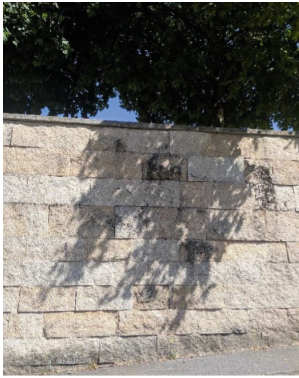
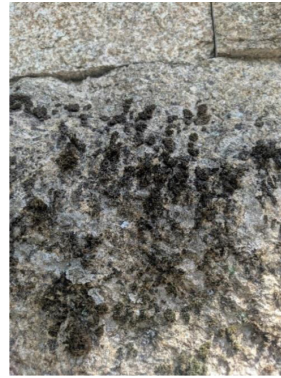
Fig. 5. Shadowed building façade.

a) Shadowed façade

b) Details of the mosses in the façade

In Figs. 5a) and b), on a facade facing west, it is possible to observe that the growths are located on the rough stones and have a more significant protrusion, and for part of the day, they are under the shade of tree branches.

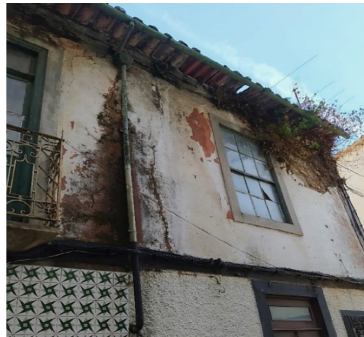
Broken tiles and leaks from downpipes are relatively common causes of biological growth. Leaks in downpipes can be due to broken pipes or insufficient sections to dispatch the volume of water from the gutters. Figure 6 (facade facing west) is an excellent example of the two situations mentioned, where it is possible to observe the presence of algae and vegetation growth.

**Fig. 6.** Vegetation and algae in building façade.

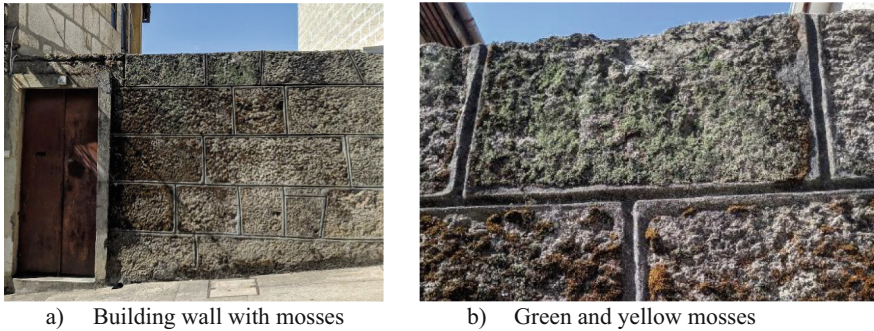
The absence of a drip tray on the top of the façade to direct water leads to a constant presence of water in the same places, providing a favourable environment for microorganisms. In Fig. 8a) and b), the façade facing south is wholly filled with mosses of different colours.

Fig. 8. Building with a stone wall with the presence of mosses.

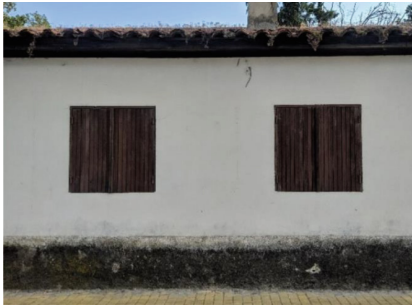
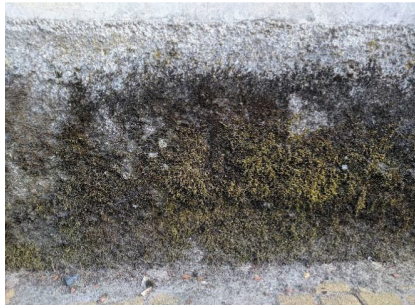
Fig. 9. Building façade with several types of BG.

In the lower parts of buildings close to the pavement, it is common for rainwater to accumulate. Even if the water does not run down the façade, the rain splashes deposit residue and wet the surface of the materials. In the long term, this action provides a favourable environment for the growth of biological colonisation. Figures 9a) and b) show a façade facing North with a significant presence of mosses and fungi in the lower part.

a) Building façade

b) Detail with fungus and mosses

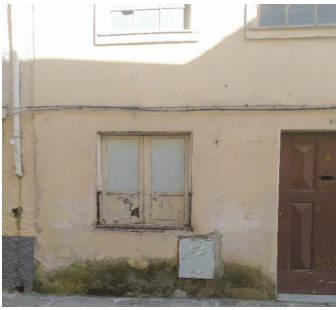
Fig. 10. Building façade with algae and mosses

The previously mentioned phenomenon also causes the appearance of algae, as shown in Fig. 10a) and b).

a) Building façade

b) Detail with algae and mosses
