# Analysis and Redesign of Simon Mazorodze and Chitungwiza Road Intersection in Harare, Zimbabwe

Department of Civil Engineering, University of Zimbabwe, P.O Box MP167 Mount Pleasant,  
Harare, Zimbabwe

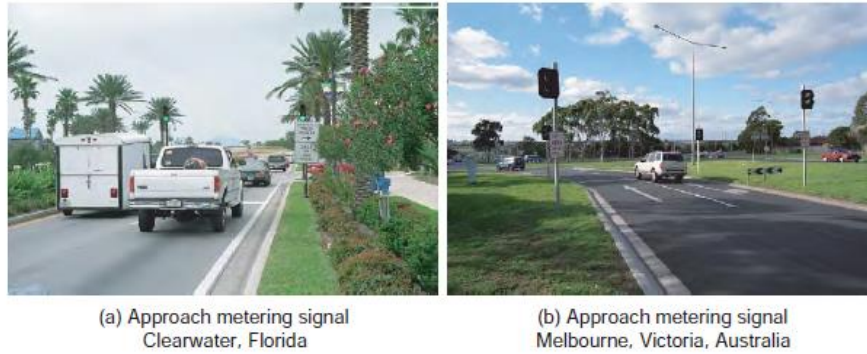
During peak periods, flow from one entry can dominate downstream entries to the point that insufficient acceptable gaps are available causing excessive delays and queues at the downstream entry. Entry metering becomes necessary at such points and is usually done by installing a traffic control signals to meter the flow as it approaches the roundabout. A basic metering system consist of two components first one consist of a queue detector on the downstream entry that is experiencing excessive delays and queues. This detector is placed relatively far back on the downstream entry to detect when there is long queue that has formed due to congestion .When a long queue is detected, the signal controller activates the metering signal. The second one consist of a metering signal on the dominant approach, preferably set far enough back from the entry to minimize confusion with the yield sign .Another method of metering is the use with appropriate timing of nearby upstream signalized intersection on the subject approach road. Unlike pure entry metering , such controls may stop vehicles from entering and leaving the roundabout .Expected queue lengths on the roundabout exits between the metering signal and the circulatory roadway should be compared with the proposed queuing space .However because of additional objectives and constraints , metering by upstream signals is generally not as effective as direct entrance metering and more than one entrance can be metered .Entry metering may generally result in bunching of traffic and

introducing more of the longer duration gaps and it is also affected by power shortages. Figure 1 shows an example of entry metering on roundabouts.

**Fig. 1.** Entry metering on roundabouts [4]

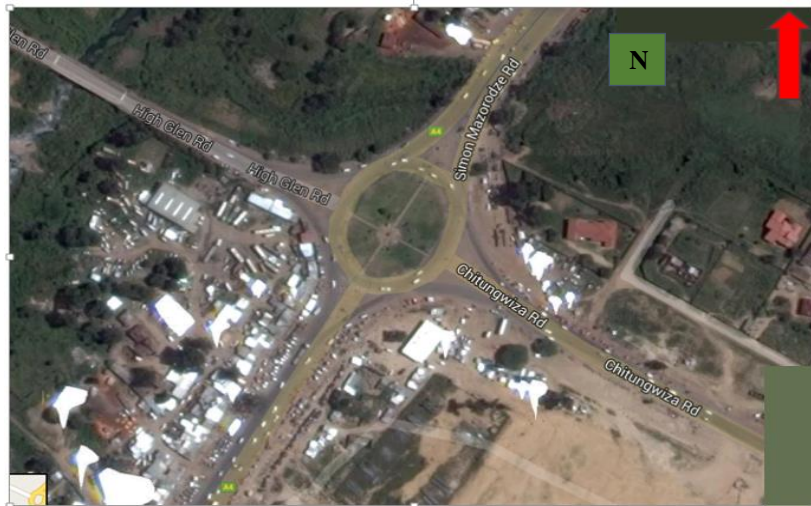
The study area is located at 17° 55' 13" South and 30° 59' 06 "East. The intersection is about 15 km from the Central Business District of Harare in Zimbabwe. A roundabout was constructed at this intersection about 20 years ago .It is a two lane kerbed roundabout with two way entry and exit on each approach .Simon Mazorodze was dualised in 2011 whist Chitungwiza Rd and High Glen Rd are two way single lane roads. Simon Mazorodze (North) crosses a small bridge less 10m from intersection whilst High Glen Road crosses Mukuvisi River less than 100 m from the intersection. Figure 2 show the aerial view of the intersection.

Fig. 2. Aerial view of the intersection from Google earth imagery

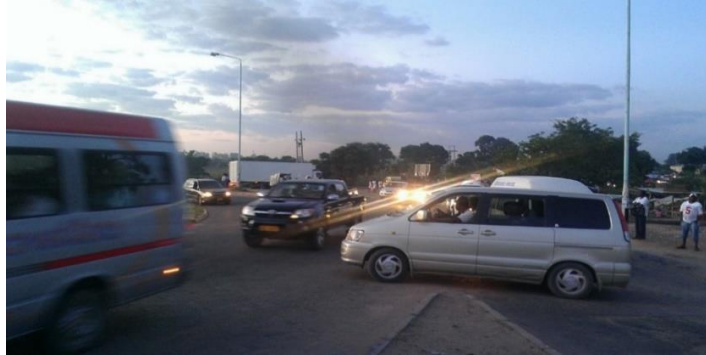
There is extensive vending within and around the intersection. No control exist on pick and drops is being implemented and this is affecting the operation of the intersection especially during the peak hours. It was also observed during peak hours that when long queues (more than 100 m) are formed, drivers become impatient and break the intersection rules and enter into the weaving zone resulting in more traffic in circulation creating less gaps for yielding traffic to enter. Accumulation of traffic also started when a large number of heavy vehicles consecutively enter into the weaving zone. Figure 3 shows some of the illegal activities taking place at the intersection.

**Fig. 3.** Evening peak hour congestion at Simon Mazorodze/Chitungwiza Intersection (16/02/2016)

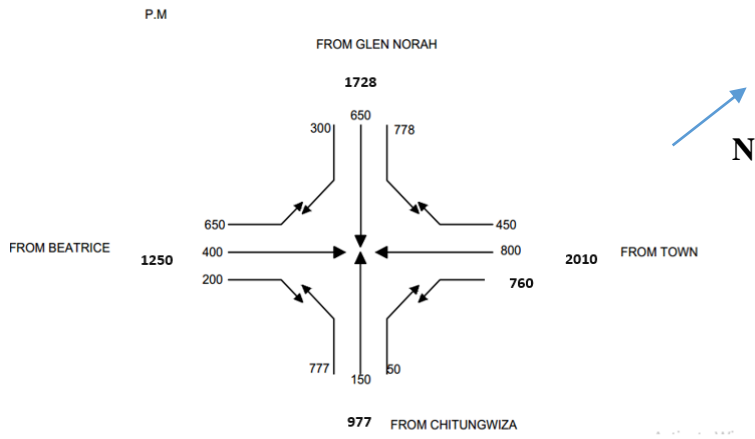
Traffic movement at the current intersection during the evening peak hour are shown in Figure 5.

**Fig. 5:** Traffic flow during the evening peak hour in pcu/hr

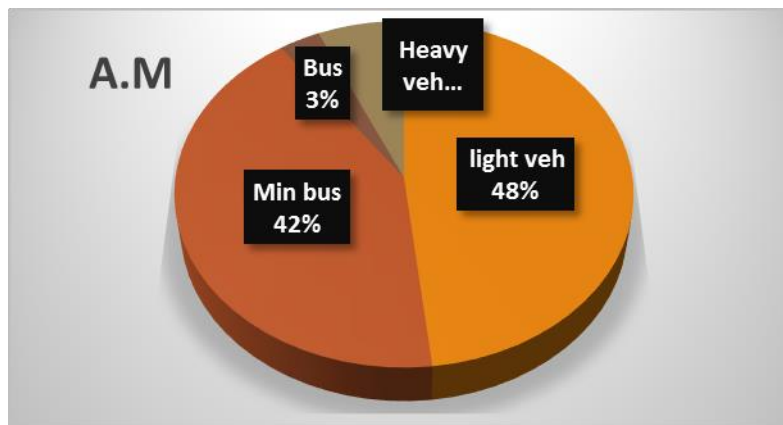
Variation of traffic composition for the morning peak hour is shown in the Figure 6.

**Fig. 6.** Traffic composition during the morning peak hour.

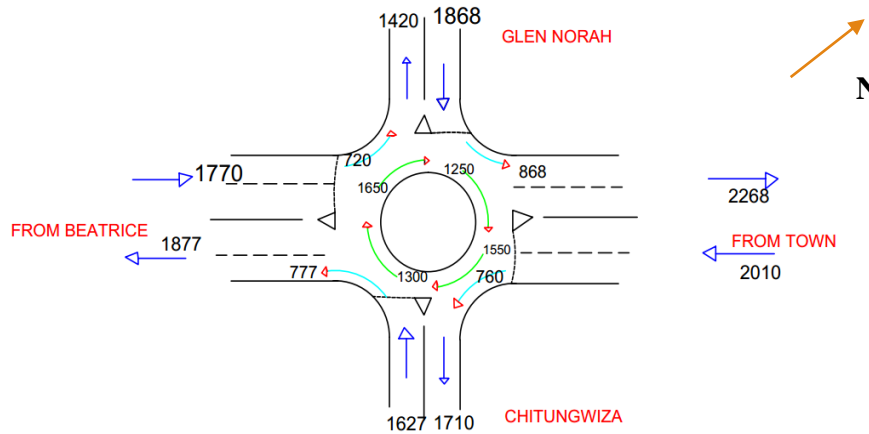
The actual turning movements for maximum flows are shown in Figure 7.

Fig. 7. Actual turning movements for the maximum flows.

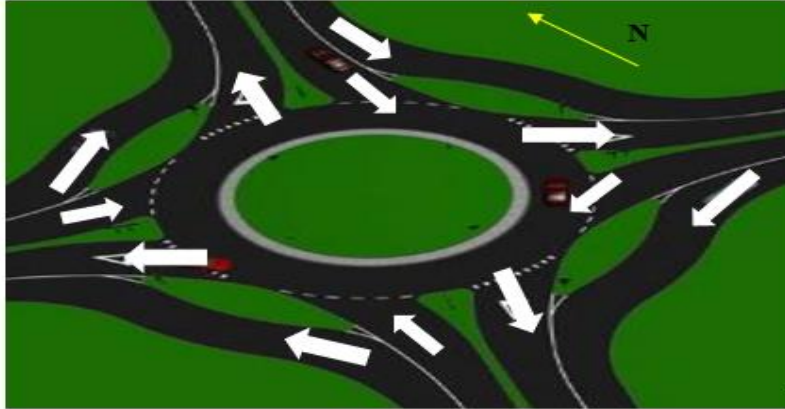
Figure 9 shows the proposed solution.

**Fig. 9.** Roundabout with slip lanes

This redesign would involve the following processes:

1. Adding bypass slip lanes adjacent to the roundabout to all approaches;
2. Widening of the entry and exit width

The current entry width is 7.5 m and the proposed width is 12.0 m, the current exit width is 5.5 m and the proposed width is 10 m .This increase results in better accommodation of large trucks resulting in less delays at the current intersection.

3. Reducing the size of the inscribed circle and widening of the circulation lanes.

The current inscribed circle is egg-shaped with a longest diameter of 78.0 m and this will be reduced to 76.0 m .This is large enough to accommodate design vehicle and maintain required deflection and increasing the capacity as well.

4. Introduction of steel guardrail along Simon Mazorodze Splitter Island
5. Construction of a retaining wall on the steep slope between Simon Mazorodze (To Town) and High Glen approach before introduction of a slip lane.

After computing the calculation it was deduced that all approaches of the current intersection had negative reserve capacities meaning that the roundabout is currently not able to cater for the entry flow .Capacity of the weaving sections was further computed after removing all the left turning traffic and all the reserve capacities changed to positive meaning the new design increases the entry capacities .The reserve capacities also remained positive after a ten years assuming a 4% traffic growth rate. It can therefore be concluded that the proposed design with bypass lanes would sufficiently improve the intersection.

With this design, all left turning traffic would bypass the intersection resulting in less conflicting vehicles, widening the entry, exit and circulatory width would increase the
