# Effect of Drainage Blanket on Reducing Uplift Pressure Under Chute Spillway: A Case Study on Megech and Ribb Dam Projects

**Abstract.** Ribb and Megech dams have been designed by same designer, both dams have similar foundation, capacity and profile. However, Ribb dam spillway was designed and constructed with drainage blanket beneath the spillway channel slab. Whereas, the design and construction of Megech Dam Spillway was without this material. This study investigates the distribution of uplift pressure and seepage at control, chute and terminal section of the spillway's foundation of the two projects with and without drainage blanket using SEEP/W software and measured data. The result showed that on Ribb dam spillway up to 14% reduction of uplift pressure around control section and an average of 5% uplift pressure reduction at chute section of the spillway was found by using drainage blanket beneath the structure. However, providing drainage blanket beneath the stilling basin slab couldn't reduce the uplift pressure rather it allows the tail water to enter and surcharge the under-slab drainage system. If this drainage sand has been used on Megech dam spillway up to 12% uplift

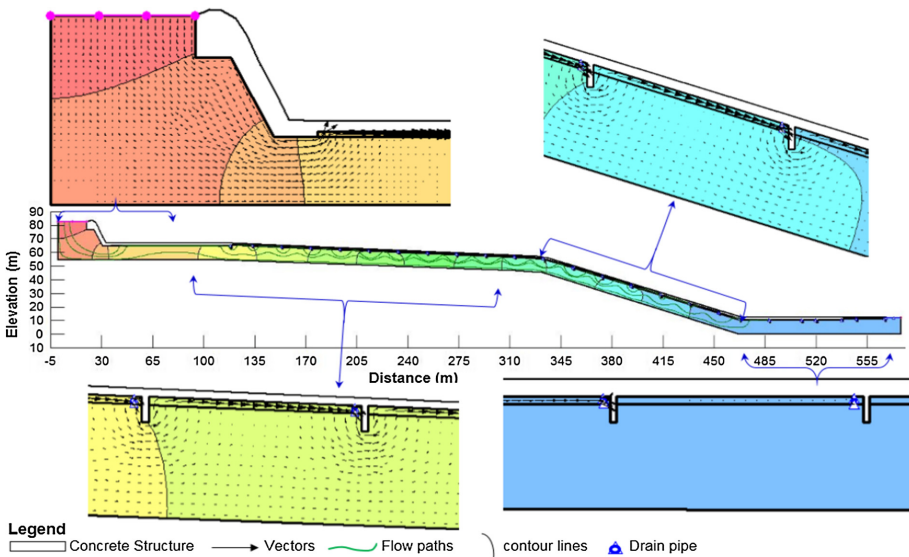
**Fig. 3.** Ribb spillway cross-section with drainage sand as designed and constructed

Figure 3 shows model simulation for Ribb Spillway cross-section with drainage blanket as designed and constructed and Fig. 4 displays model simulation of this Spillway cross-section without drainage blanket beneath the channel slab. In the same way the model is simulated for Megech Dam Spillway for the original design without drainage blanket beneath the chute slab and with sand blanket in place as of Fig. 9 and 10 respectively.

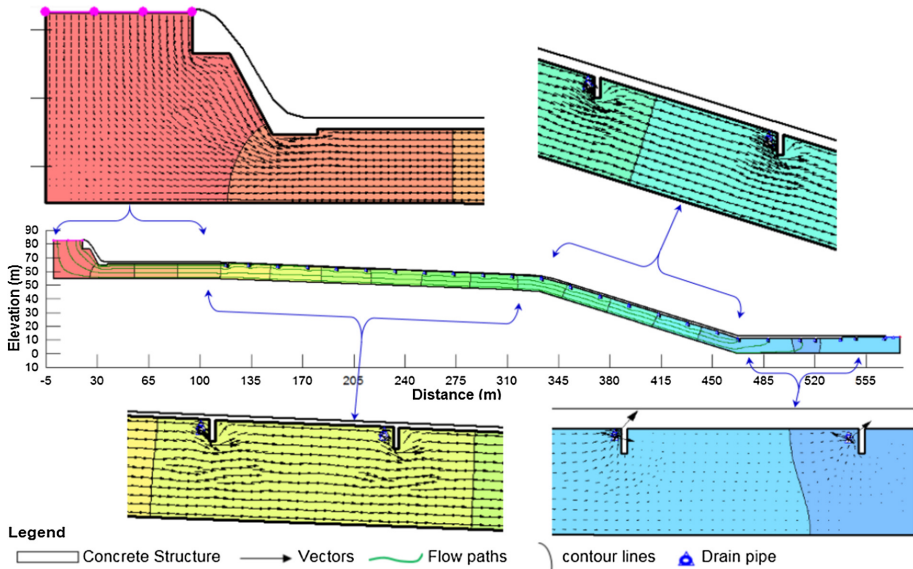
**Fig. 4.** Ribb spillway cross-section without drainage sand beneath channel chute slab

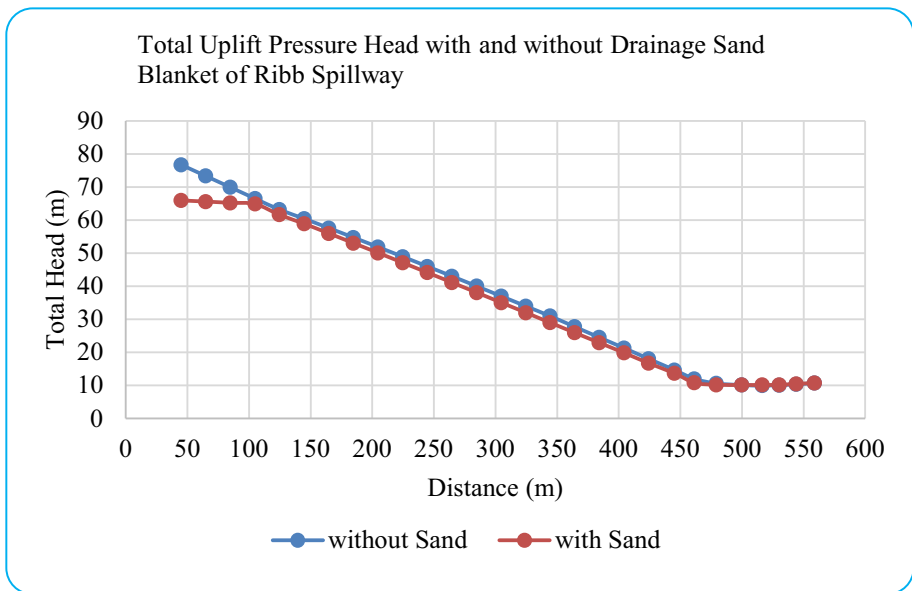
The negative value at stilling basin section of the spillway indicates that the total head becomes greater when there is drainage blanket and perforated drain pipe beneath the stilling basin slab. The elevation head at this section is below the downstream river water level. The permeability of the drainage sand placed beneath the stilling basin slab is higher than the permeability of the downstream foundation. Due to this elevation head and permeability variation there is back water flow from downstream to stilling basin as shown on Fig. 9 which develops pore water pressure under the slab structure. The bedding slope of both transversal and longitudinal perforated pipe is horizontal which keeps the accumulated water to be stagnant rather than easily drain. That is why the total

head becomes higher when there is drainage sand blanket beneath the stilling basin slab (Fig. 5).

**Fig. 5.** Total uplift head comparison of Ribb spillway with and without drainage blanket

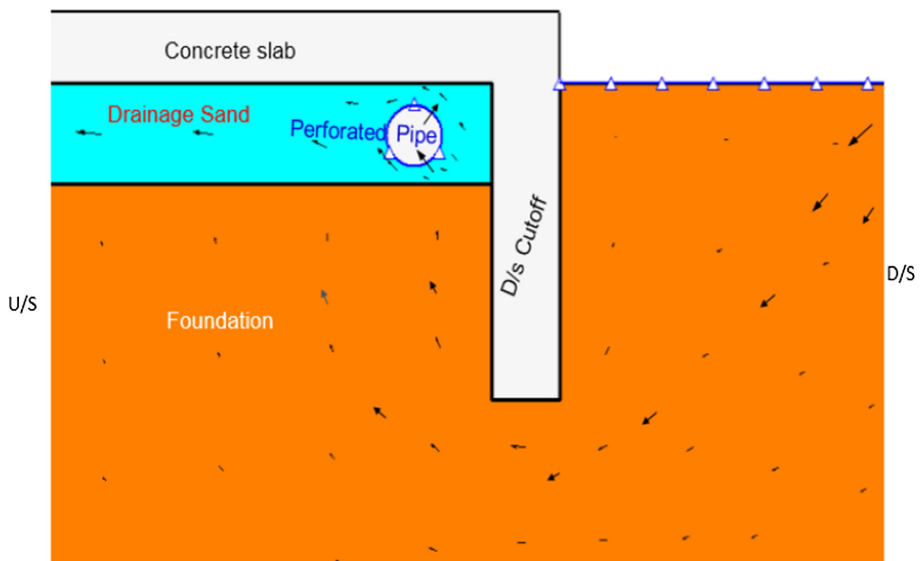
**Fig. 6.** Entering and surcharging of d/s tail water to the under-slab drainage system of stilling basin

The model simulation result of both Megech dam spillway and Ribb Dam Spillway shows no reduction of uplift pressure in the stilling basin by using drainage blanket beneath the stilling basin slab rather it allows the tail water to enter and surcharge the under-slab drainage system as shown in Fig. 6. The slope of the stilling basin is 0% towards downstream and the ground level of the abutment behind the wall on each side (left and right) of the basin as well as the level of tail water is above the foundation of the stilling basin floor on both Megech dam spillway and Ribb Dam Spillway. Due to this elevation difference the drainage sand provided beneath stilling basin slab can't drain the develop water. This situation enforces the water developed under the stilling basin slab to be stagnant that increases the uplift pressure.

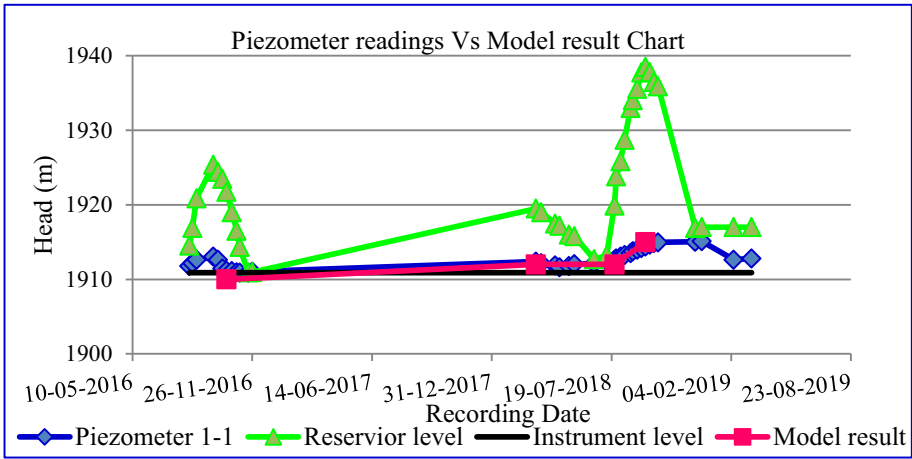
**Fig. 7.** Comparison of measured head and model result of Ribb spillway

There are many instruments installed on Ribb Dam at different locations to monitor the dam and its appurtenant structures. Piezometer 1-1 is one of a vibrating wire piezometer which was installed in the abutment foundation near to the spillway to measure ground water elevations and pore water pressures around spillway foundations. Data was recorded every week from this piezometer. More than three years data from piezometer 1-1 was taken for validation purpose of the numerical model.

The model was simulated for different reservoir levels (1920, 1925, and 1938) m amsl which are the peak reservoir level at different season as shown in Fig. 7. The model result taken from similar location of piezometer 1-1 at each stated reservoir level model output was compared with the measured values taken at the same reservoir level. The relationship of measured head and model result is direct as shown on Fig. 8.

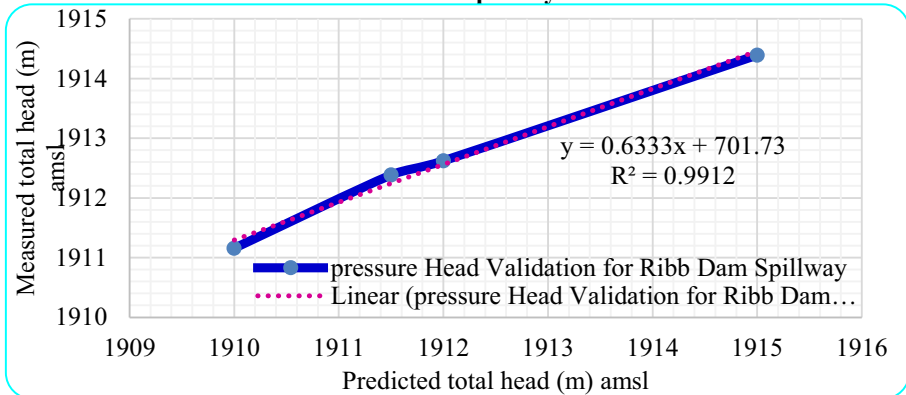
**Fig. 8.** Pressure head validation for Ribb dam spillway

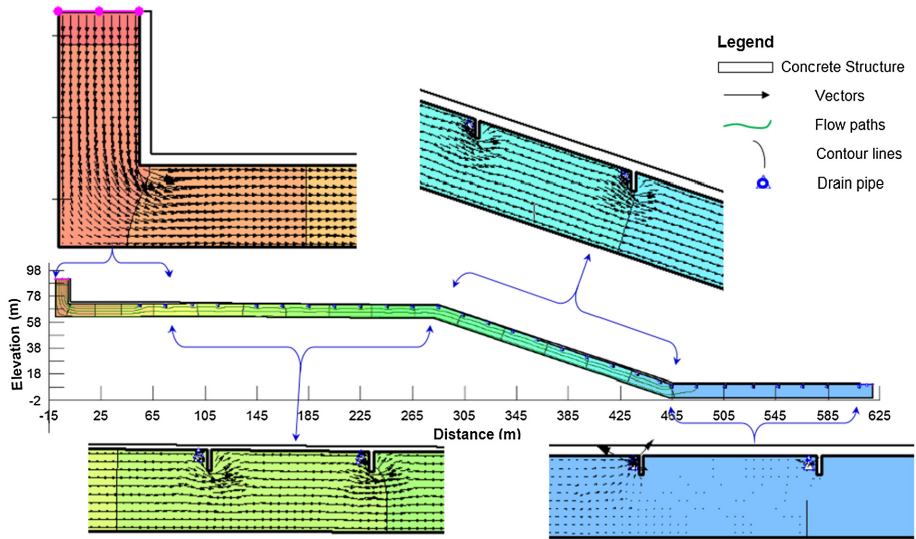
**Fig. 9.** Megech spillway cross-section without drainage sand as designed and constructed

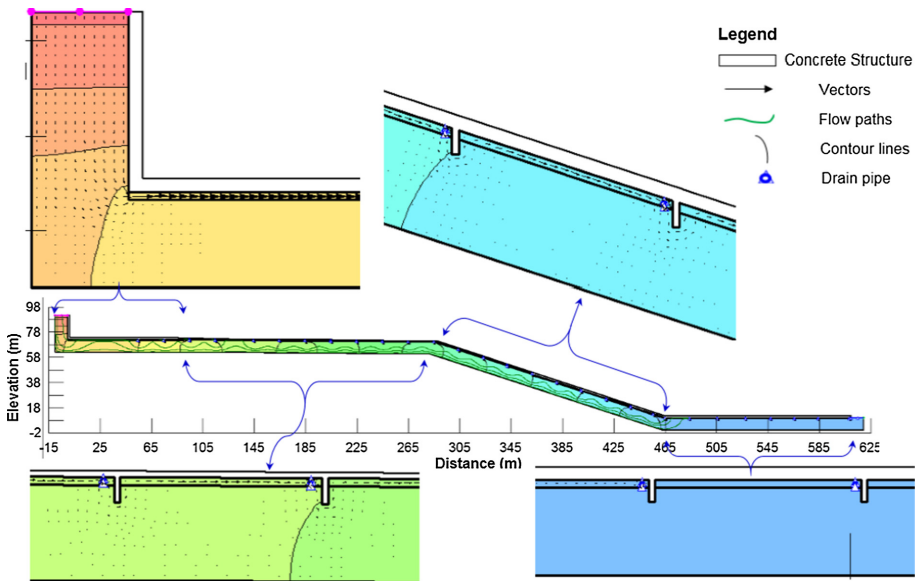
**Fig. 10.** Megech spillway cross-section with drainage sand beneath channel slab

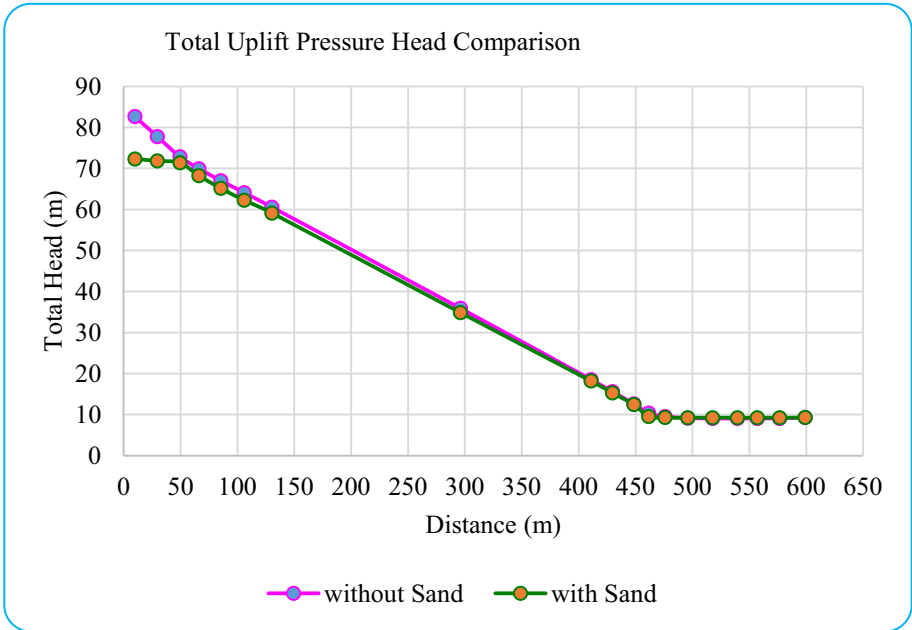
Fig. 11. Residual head comparison of Megech spillway with and without drainage blanket

The ground water level at Megech spillway foundation was directly measured by using an apparatus called deep meter during borehole drilling for anchor bar installation throughout the length of the spillway at 20 m interval. The model result was taken from the selected location for ground water measurement. The measured head and model result were compared and the relationship is direct (Figs. 11 and 12).

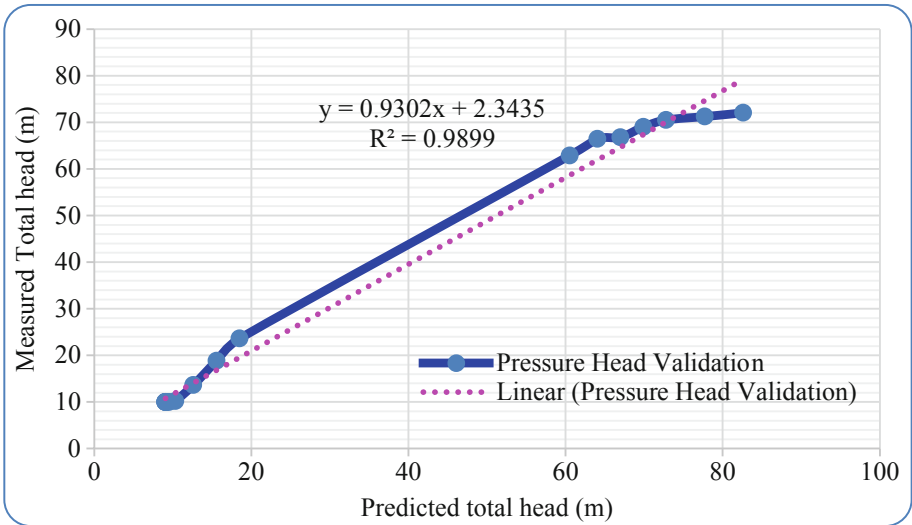
Fig. 12. Pressure head validation for Megech dam spillway

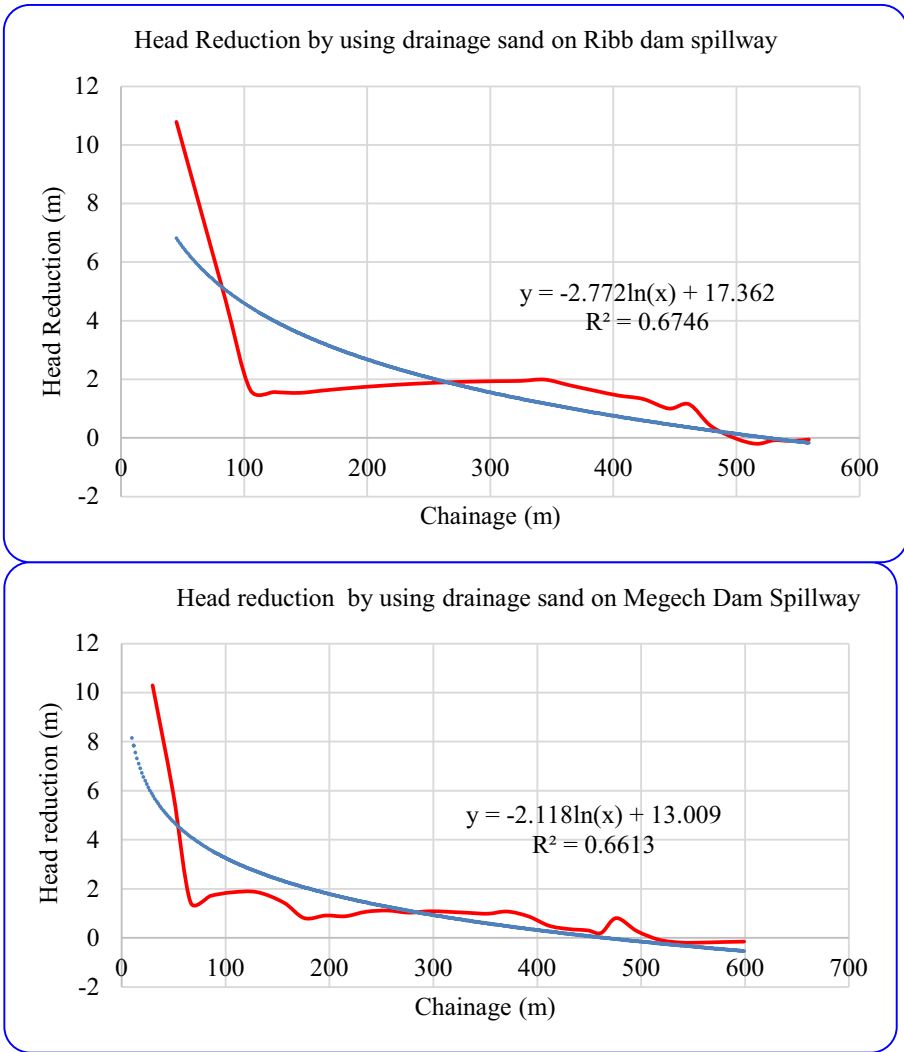
The drainage sand provided beneath the structure chute slab reduces the uplift force acting on the structure slab as shown in Fig. 13 throughout the spillway Chainage.

Fig. 13. Reduction of uplift pressure throughout the spillway Chainage by using drainage sand

Cutoff walls were designed and constructed within 20 m interval throughout the spillway reach and perforated transversal drain pipes were installed parallel to each cutoff wall on both Ribb and Megech spillways. This arrangement causes the uplift

reduction by providing drainage sand beneath the structure not same throughout the chute and ups and downs as shown in Fig. 13.

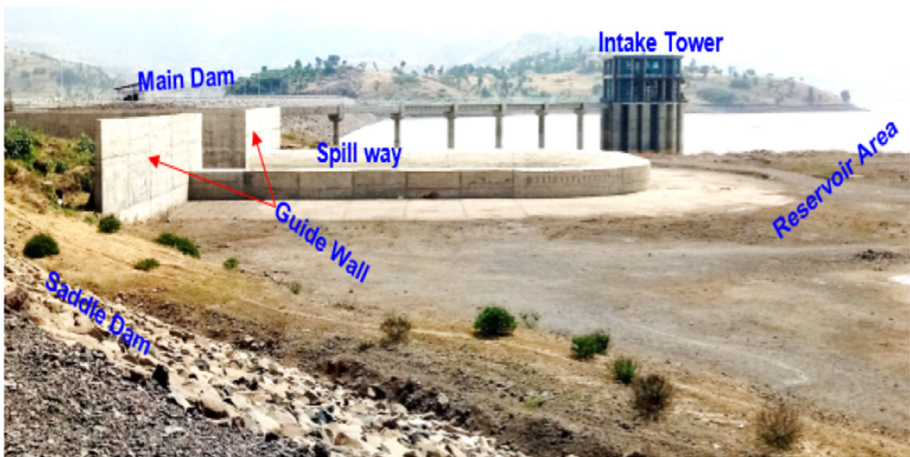
**Seepage and Uplift Pressure at Control and Chute Sections.** The main seepage reduction zone for a chute spillway is typically located at the control section area [13]. The Control Section at Ribb Dam Spillway includes an impervious blanket constructed within the cross section of the approach channel, an impervious embankment constructed behind the abutment walls, a cutoff wall and a grout curtain which extends beneath control structure that makes the spillway safe against uplift pressure as shown in Fig. 14.

Fig. 14. Approach and control section of Ribb dam spillway

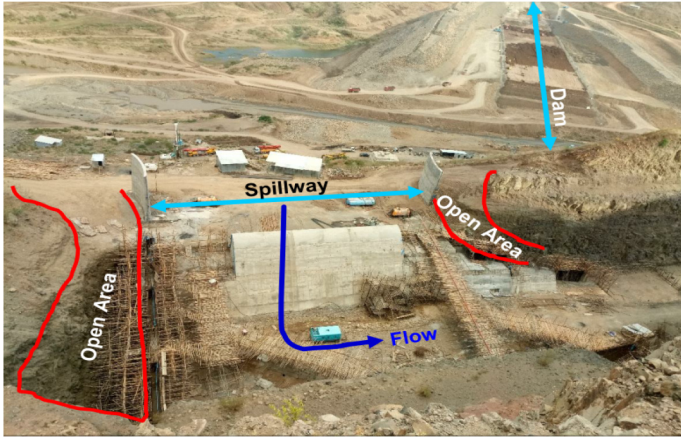
Whereas, the topographic condition of Megech dam spillway requires an impervious embankment which should be constructed behind the abutment walls or any other barrier to block the reservoir water entering to the back of the approach wall that may increase the uplift pressure under the near chute slab as shown on Fig. 15.

**Fig. 15.** Approach and control section of Megech dam spillway

The topographic condition of Megech dam spillway around control section requires an impervious embankment which should be constructed behind the abutment walls or any other barrier to block the reservoir water entering to the back of the approach wall that may increase the uplift pressure under the near chute slab.

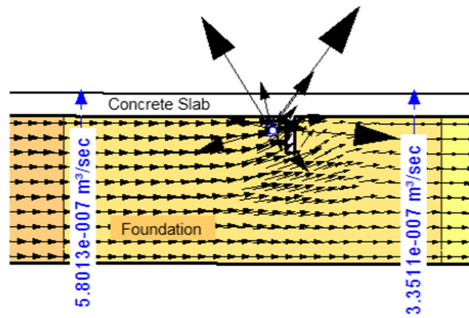
A longitudinal pipe is used to connect the manholes and convey seepage water into the outlet channel. This drainage system reduces the seepage and uplift pressure from upstream to downstream gradually. Figure 16 shows the interception of the coming seepage by transverse perforated drainpipes and reduction of uplift pressure towards downstream.

**Fig. 16.** Interception of Seepage flow under foundation of Megech dam spillway
